**Flood Control Project Maintenance
Levee Inspections**
LMA District Cover Sheet
Spring 2018 Levee Inspection Results

Reclamation District No. 0017 Mossdale

Spring 2018 Levee Inspection Results

Waterway			Bank	Unit Miles
Unit No. 01 French Camp Slough			Left	1.76
	Spring (March - May)	Summer (June - August)	(September - November) Fall	Winter (December - February)
Unit Maintenance Rating (Fall Only)				
Date of Inspection	5/8/2018 - 5/8/2018			
DWR Inspector	Richard Willoughby			
Accompanied By	Richard Toy KSN			
	Scott Solari RD 17

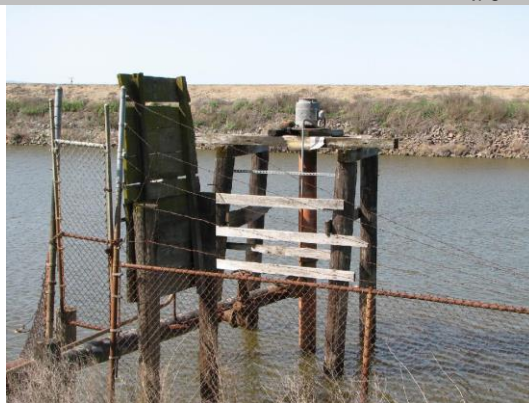
Photo 3 of 3 : UCIP_SP_2018_40681_72330.jpg

Comment Code						
Inspector Comment						
FS_ID:40681 DS_ID:44 EP_NO: 15079 Repair Type: Non-Urgent Crossing Status: Found UCIP Comments: If crossing is no longer in use owner will need to coordinate with DWR inspector and CVFPB to remove according to Title 23 requirements. Unable to determine if crossing is in use. FIELD_STRUCT_DESC: 14-inch steel irrigation pipe through levee, 1.17 feet below levee crown. Siphon breaker on waterside (WS) shoulder. Pump on platform in channel, walkway from pump platform to the top of the riverbank, standpipe located 12 feet from landside (LS) toe. (14-inch pipe installed under Permit No. 15079-1990 - San Joaquin County Parks and Joe P. Aven, authorized work also include installation of 10-inch pipe in general area and the removal of two existing pipes, 10-inch pipe and 6-inch pipe) [Additional Reference(s): DWR Levee Logs, 1981 and 2003] FS Date: 2/4/2010

Pump station fenced off on waterward side.

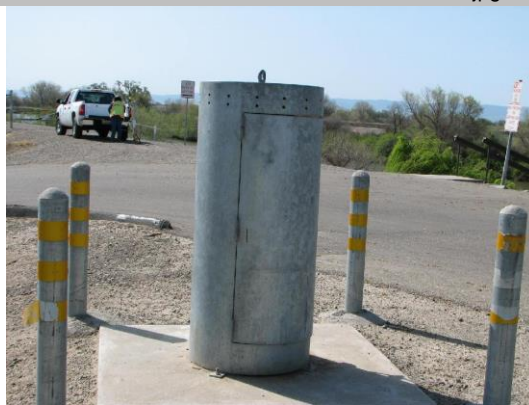
Photo 2 of 3 : UCIP_SP_2018_40682_72321.jpg

FS_ID:40682
DS_ID:99
EP_NO: 17643
Repair Type: Non-Urgent
Crossing Status: Found
UCIP Comments: Need to coordinate with owner to determine when the other 3 crossings will become online.
FIELD_STRUCT_DESC: [Stonebridge Pump Station/Dos Reis Road Outfall Structure] 30-inch and 36-inch combination cement motar lined and coated steel drainage pipe through the levee, 2-feet below the levee crown. Concrete headwall on waterside (WS) toe and a 36-inch tidal flex valve on outlet of pipe. 36-inch pipe section starts at WS headwall and is reduced with a 30-inch pipe on WS. The 30-inch pipe continues through from WS to LS levee. Structure was designed for 5 crossings however only 1 crossing is active (30-inch pipe and 36-inch combination pipe through the levee authorized under Permit No. 17643, 2005 - City of Lathrop, structure can accommodate five 36-inch pipes discharge pipes - only one 36-inch pipe active).

Relief valve located on landward shoulder.

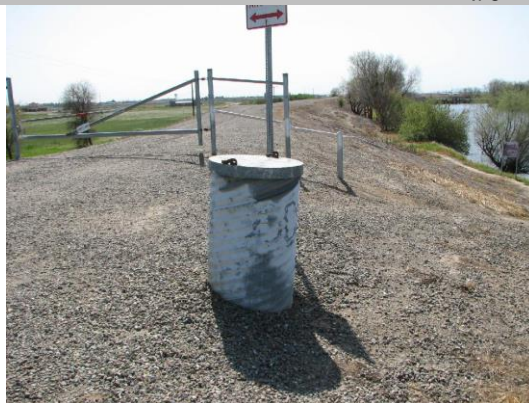
Photo 2 of 3 : UCIP_SP_2018_40683_72332.jpg

CMP riser located on waterward shoulder.

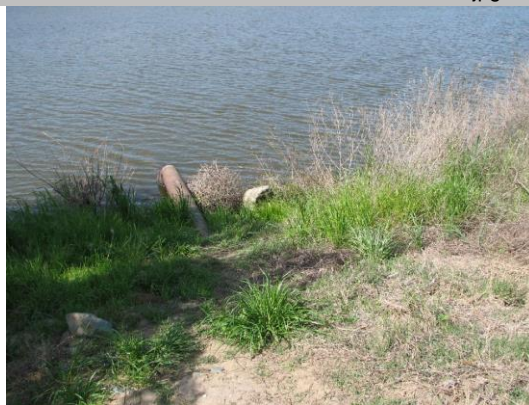
Photo 3 of 3 : UCIP_SP_2018_40683_72335.jpg

Pipe visible on waterward side.

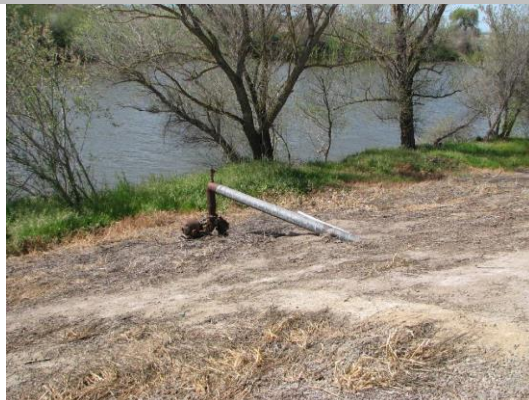
Photo 2 of 3 : UCIP_SP_2018_40684_72342.jpg

View of waterward side.

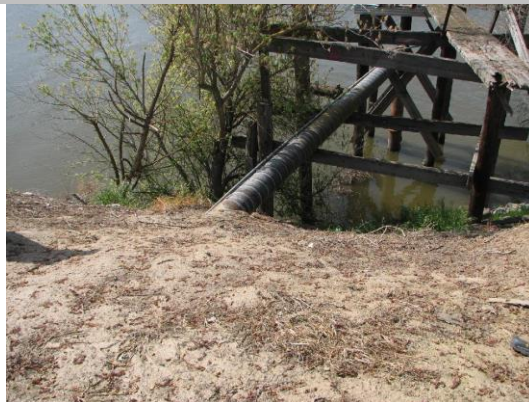
Photo 2 of 3 : UCIP_SP_2018_40685_72350.jpg

Pipe daylight on waterward side.

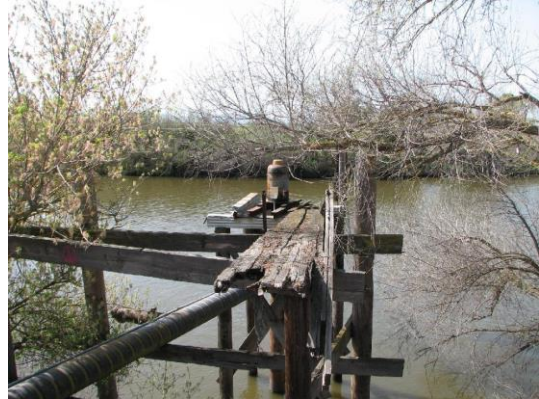
Photo 3 of 3 : UCIP_SP_2018_40685_72348.jpg

Pump station located on platform located on waterward side.

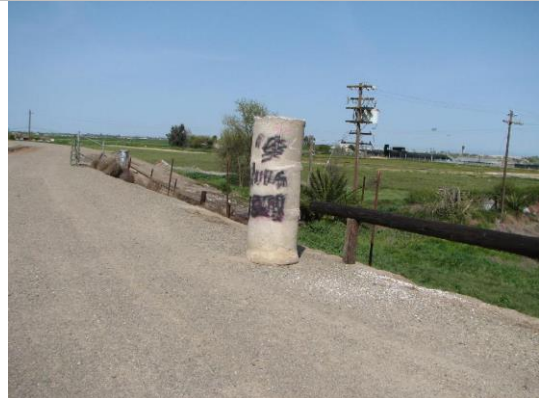
Photo 1 of 2 : UCIP_SP_2018_40686_72353.jpg

LM Start	7.73	Rating **	M	Issue No.	123	
LM End	7.73	Issue Type +	En	Location *		
Category	Supplemental			GPS Latitude/Longitude		
				Start	End	
Item	DWR UCIP Field Study			37.826031 °	37.826031 °	
				-121.309569 °	-121.309569 °	
DWR ID						
Comment Code						
Inspector Comment						
FS_ID:40686						
DS_ID:804						
EP_NO: N/A						
Repair Type: Non-Urgent						
Crossing Status: Indicator Found						
UCIP Comments: Unable to find any appurtenances need to coordinate with owner to obtain additional informaiton about crossing. Standpipe appears abandoned. If crossing is no longer in use owner will need to coordinate with DWR inspector and CVFPB to remove according to Title 23 requirements. Unable to determine if crossing is in use.						
FIELD_STRUCT_DESC: Standpipe located on levee crown.						
FS Date: 2/4/2010

Standpipe located on levee crown.

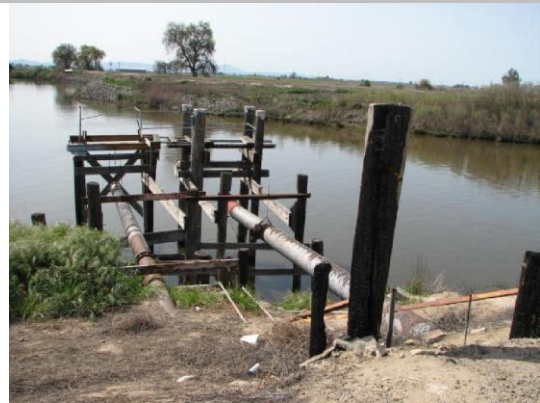
Photo 1 of 3 : UCIP_SP_2018_40687_72357.jpg

Comment Code					
Inspector Comment					
FS_ID:40687 DS_ID:100 EP_NO: 15082 Repair Type: Non-Urgent Crossing Status: Found UCIP Comments: Pumps were removed and no power connection visible. Crossing appears abandoned. If crossing is no longer in use owner will need to coordinate with DWR inspector and CVFPB to remove according to Title 23 requirements. Unable to determine if crossing is in use. FIELD_STRUCT_DESC: 20-inch asphalt coated and wrapped steel irrigation pipe through levee, 2.1-feet below the crown. Pump missing from platform on waterside (WS). Siphon breaker inside 24-inch corrugated metal pipe (CMP) riser on landside (LS) shoulder. (20-inch pipe installed under Permit No. 15082, 1989 - I. N. Robinson, Jr., also authorized under permit two existing 14-inch pipes removed and installation of 16-inch pipe in general area) FS Date: 2/4/2010

View of waterward side.

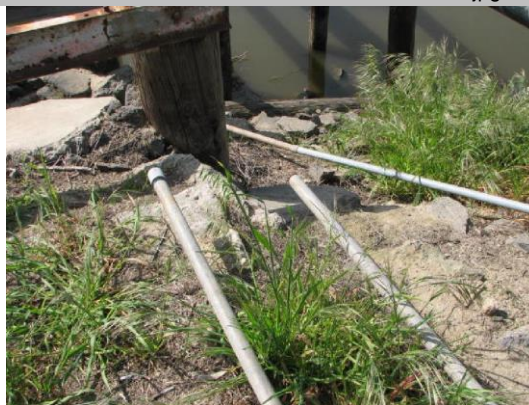
Photo 3 of 3 : UCIP_SP_2018_40687_72358.jpg

Conduit lines present on waterward side--no connection.

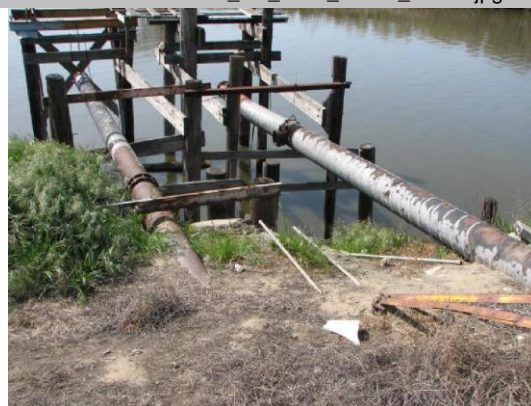
Photo 1 of 3 : UCIP_SP_2018_40688_72361.jpg

Comment Code						
Inspector Comment						
FS_ID:40688 DS_ID:288 EP_NO: 15082 Repair Type: Non-Urgent Crossing Status: Found UCIP Comments: Pump was removed and no power connection visible. Crossing appears abandoned. If crossing is no longer in use owner will need to coordinate with DWR inspector and CVFPB to remove according to Title 23 requirements. Unable to determine if crossing is in use. FIELD_STRUCT_DESC: 16- inch asphalt coated and wrapped steel irrigation pipe through levee, 2.6-feet below the crown. Pump missing from platform on waterside (WS). Siphon breaker inside 24-inch corrugated metal pipe (CMP) riser on landside (LS) shoulder. 1.5-inch galvanized iron electrical conduit at same location. (16-inch pipe installed under Permit No. 15082, 1989 - I. N. Robinson, Jr., also authorized under permit two existing 14-inch pipes removed and installation of 20-inch pipe in general area) FS Date: 2/4/2010

View of pipe on waterward side.

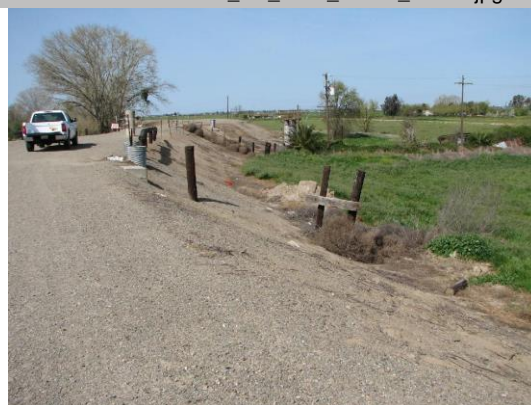
Photo 2 of 3 : UCIP_SP_2018_40688_72360.jpg

View of landward side.

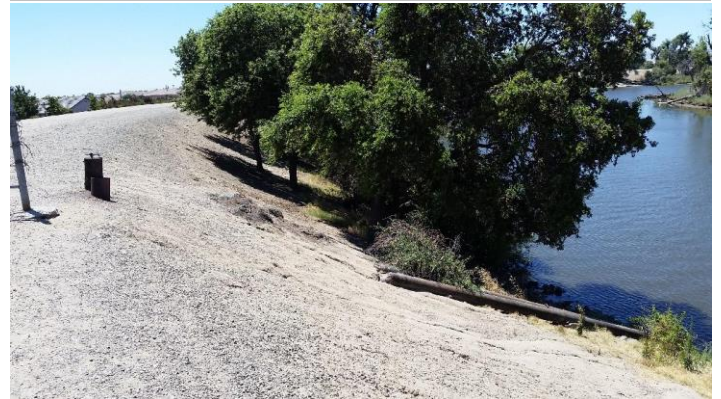
Photo 1 of 3 : UCIP_SP_2018_49999_75741.jpg

FS_ID:49999
DS_ID:285
EP_NO: 15083
Repair Type: Urgent
Crossing Status: Found
UCIP Comments: 7/12/2016 Same as last inspection--WS pipe section deteriorated. Per Rick Toy, KSN-District Engineer, this crossing is currently owned by the City of Lathrop. Need to coordinate with the City of Lathrop to submit name change to the CVFPB and for the City to provide future use for this crossing. Recommend internal integrity inspection of section of the pipe through the levee. (DWR UCIP - omagana)5/21/2015 Pipe is still in same condition. Need to contact KSN, LMA engineering firm, to determine update on crossing. (DWR UCIP - omagana)2/04/2010 Pipe wall has corroded through--wall missing from pipe section located on waterward side. Recommend investigating the pipe integrity through levee section. Damage to pipe has eroded the levee slope on waterward side. Recommend LMA superintendent contact owner to stop using crossing and coordinate with CVFPB to address pipe leak. Owner will need to coordinate with DWR inspector and CVFPB. (DWR UCIP - omagana)

View of WS.

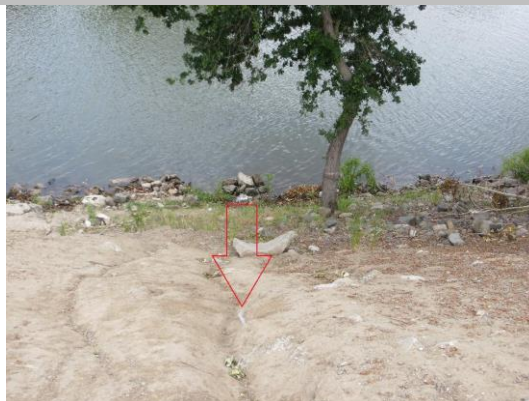
Photo 2 of 2 : UCIP_SP_2018_45453_74113.jpg

1.5-inch electrical conduit only appurtanance still visible on WS slope.

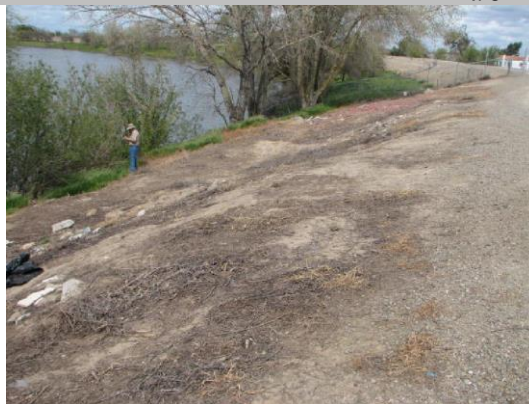
Photo 2 of 3 : UCIP_SP_2018_40695_72418.jpg

Comment Code					
Inspector Comment					
FS_ID:40695 DS_ID:51 EP_NO: 15055 Repair Type: Non-Urgent Crossing Status: Found UCIP Comments: Pipe is not connected on waterward side. Crossing is non-functional recommend contacting owner to determine status of crossing. If crossing is no longer used need to coordinate with CVFPB for proper abandonment. FIELD_STRUCT_DESC: 16-inch steel irrigation pipe through levee, 2.77 feet below levee crown. Siphon breaker on landside (LS) shoulder. Slant pump on waterside (WS) slope, standpipe located 11 feet from the LS toe. (16-inch pipe authorized under Permit No. 15055, 1989 - F. G. and B. J. Terry, existing 14-inch pipe removed) [Additional Reference(s): DWR Levee Logs, 1981 and 2003] FS Date: 2/4/2010

View of waterward side.

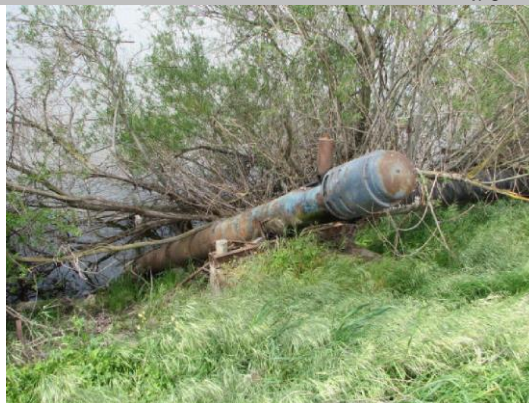
Photo 3 of 3 : UCIP_SP_2018_40695_72421.jpg

Item	DWR UCIP Field Study			37.803410 °		37.803410 °
				-121.312031 °		-121.312031 °
DWR ID						
Comment Code						
Inspector Comment						
FS_ID:40695						
DS_ID:51						
EP_NO: 15055						
Repair Type: Non-Urgent						
Crossing Status: Found						
UCIP Comments: Pipe is not connected on waterward side. Crossing is non-functional recommend contacting owner to determine status of crossing. If crossing is no longer used need to coordinate with CVFPB for proper abandonment.						
FIELD_STRUCT_DESC: 16-inch steel irrigation pipe through levee, 2.77 feet below levee crown. Siphon breaker on landside (LS) shoulder. Slant pump on waterside (WS) slope, standpipe located 11 feet from the LS toe. (16-inch pipe authorized under Permit No. 15055, 1989 - F. G. and B. J. Terry, existing 14-inch pipe removed) [Additional Reference(s): DWR Levee Logs, 1981 and 2003]						
FS Date: 2/4/2010

Slant pump located on waterward side.

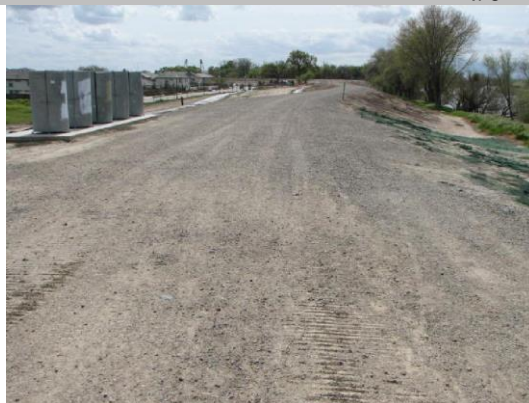
Photo 1 of 3 : UCIP_SP_2018_40696_72440.jpg

Comment Code					
Inspector Comment					
FS_ID:40696 DS_ID:103 EP_NO: 17792 Repair Type: Non-Urgent Crossing Status: Found UCIP Comments: Surface erosion on waterward slope--Need to contact owner. FIELD_STRUCT_DESC: [Mossdale Outfall] 1 of 6. 30-inch steel drainage pipe through levee at unknown depth. Structure is part of Lathrop City Stormwater Pump Station 112. Station consists 6 drainage pipes, pump station, air release valves, and concrete headwall. Air release valves located inside risers are located on landside (LS) shoulder on top of concrete pad. Concrete headwall and gates located on waterside (WS). (six 30-inch pipes authorized under Permit No. 17792, 2005 - City of Lathrop) FS Date: 2/4/2010

Overview of levee crown at crossing.

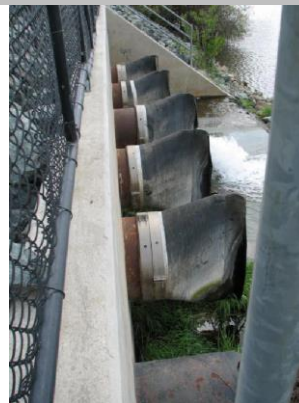
Photo 3 of 3 : UCIP_SP_2018_40696_72449.jpg

Concrete headwall and gates located on waterward toe.

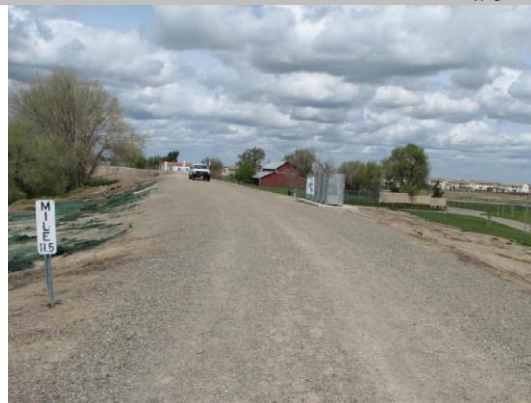
Photo 1 of 3 : UCIP_SP_2018_40697_72452.jpg

Comment Code					
Inspector Comment					
FS_ID:40697 DS_ID:473 EP_NO: 17792 Repair Type: Non-Urgent Crossing Status: Found UCIP Comments: Surface erosion on waterward slope--need to contact owner. FIELD_STRUCT_DESC: [Mossdale Outfall] 2 of 6. 30-inch steel drainage pipe through levee at unknown depth. Structure is part of Lathrop City Stormwater Pump Station 112. Station consists 6 drainage pipes, pump station, air release valves, and concrete headwall. Air release valves located inside risers are located on landside (LS) shoulder on top of concrete pad. Concrete headwall and gates located on waterside (WS). (six 30-inch pipes authorized under Permit No. 17792, 2005 - City of Lathrop) FS Date: 2/4/2010

Overview of levee crown at crossings.

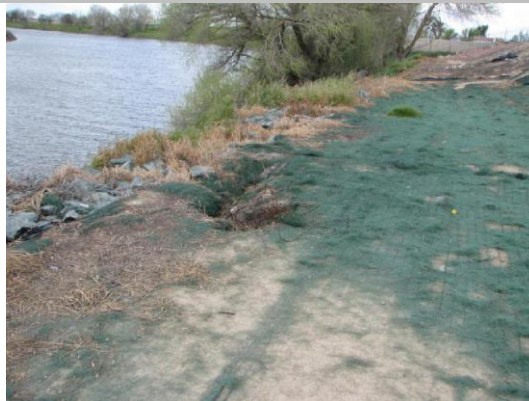
Photo 3 of 3 : UCIP_SP_2018_40697_72450.jpg

Item	DWR UCIP Field Study			37.802904 °	37.802904 °	
				-121.311946 °	-121.311946 °	
DWR ID						
Comment Code						
Inspector Comment						
FS_ID:40697 DS_ID:473 EP_NO: 17792 Repair Type: Non-Urgent Crossing Status: Found UCIP Comments: Surface erosion on waterward slope--need to contact owner. FIELD_STRUCT_DESC: [Mossdale Outfall] 2 of 6. 30-inch steel drainage pipe through levee at unknown depth. Structure is part of Lathrop City Stormwater Pump Station 112. Station consists 6 drainage pipes, pump station, air release valves, and concrete headwall. Air release valves located inside risers are located on landside (LS) shoulder on top of concrete pad. Concrete headwall and gates located on waterside (WS). (six 30-inch pipes authorized under Permit No. 17792, 2005 - City of Lathrop) FS Date: 2/4/2010

Surface erosion visible on waterward berm edge.

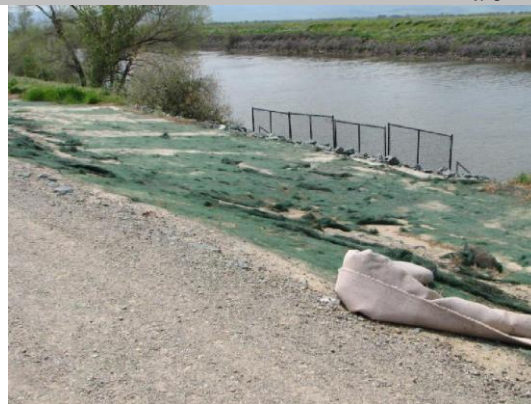
Photo 2 of 3 : UCIP_SP_2018_40698_72477.jpg

Comment Code					
Inspector Comment					
FS_ID:40698 DS_ID:474 EP_NO: 17792 Repair Type: Non-Urgent Crossing Status: Found UCIP Comments: Surface erosion on waterward slope--need to contact owner. FIELD_STRUCT_DESC: [Mossdale Outfall] 3 of 6. 30-inch steel drainage pipe through levee at unknown depth. Structure is part of Lathrop City Stormwater Pump Station 112. Station consists 6 drainage pipes, pump station, air release valves, and concrete headwall. Air release valves located inside risers are located on landside (LS) shoulder on top of concrete pad. Concrete headwall and gates located on waterside (WS). (six 30-inch pipes authorized under Permit No. 17792, 2005 - City of Lathrop) FS Date: 2/4/2010

View of waterward side.

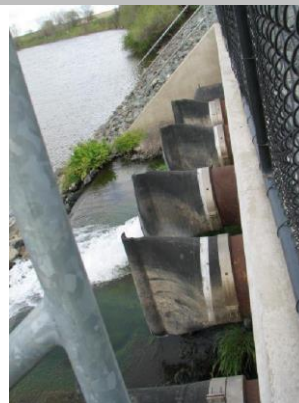
Photo 3 of 3 : UCIP_SP_2018_40698_72474.jpg

Outlet structure located on waterward toe.

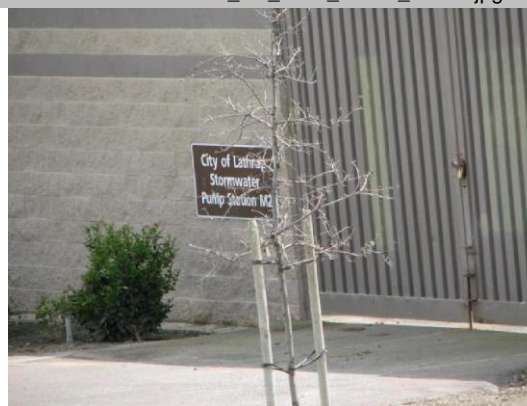
Photo 1 of 3 : UCIP_SP_2018_40699_72458.jpg

Comment Code					
Inspector Comment					
FS_ID:40699 DS_ID:475 EP_NO: 17792 Repair Type: Non-Urgent Crossing Status: Found UCIP Comments: Surface erosion on waterward slope--need to contact owner. FIELD_STRUCT_DESC: [Mossdale Outfall] 4 of 6. 30-inch steel drainage pipe through levee at unknown depth. Structure is part of Lathrop City Stormwater Pump Station 112. Station consists 6 drainage pipes, pump station, air release valves, and concrete headwall. Air release valves located inside risers are located on landside (LS) shoulder on top of concrete pad. Concrete headwall and gates located on waterside (WS). (six 30-inch pipes authorized under Permit No. 17792, 2005 - City of Lathrop) FS Date: 2/4/2010

City of Lathrop Stormwater Pump Station 112.

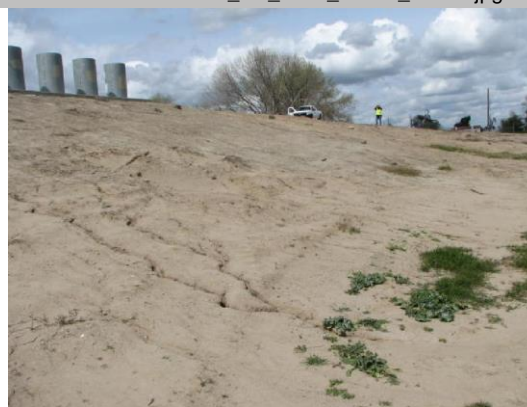
Photo 2 of 3 : UCIP_SP_2018_40699_72457.jpg

View of landward side.

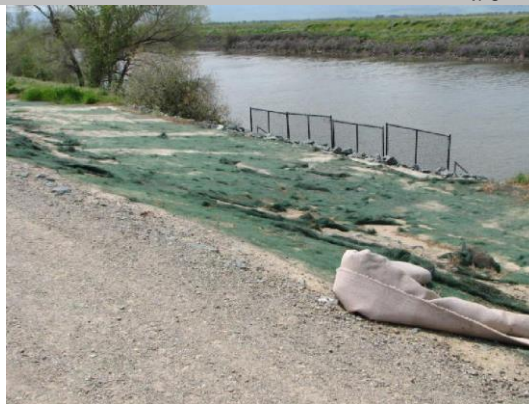
Photo 2 of 3 : UCIP_SP_2018_40700_72467.jpg

Comment Code					
Inspector Comment					
FS_ID:40700 DS_ID:476 EP_NO: 17792 Repair Type: Non-Urgent Crossing Status: Found UCIP Comments: Surface erosion on waterward slope--need to contact owner. FIELD_STRUCT_DESC: [Mossdale Outfall] 5 of 6. 30-inch steel drainage pipe through levee at unknown depth. Structure is part of Lathrop City Stormwater Pump Station 112. Station consists 6 drainage pipes, pump station, air release valves, and concrete headwall. Air release valves located inside risers are located on landside (LS) shoulder on top of concrete pad. Concrete headwall and gates located on waterside (WS). (six 30-inch pipes authorized under Permit No. 17792, 2005 - City of Lathrop) FS Date: 2/4/2010

View of waterward side.

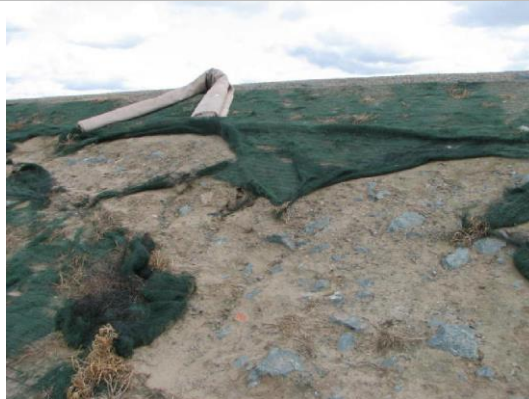
Photo 3 of 3 : UCIP_SP_2018_40700_72465.jpg

Item	DWR UCIP Field Study			37.802854 °		37.802854 °
				-121.311948 °		-121.311948 °
DWR ID						
Comment Code						
Inspector Comment						
FS_ID:40700 DS_ID:476 EP_NO: 17792 Repair Type: Non-Urgent Crossing Status: Found UCIP Comments: Surface erosion on waterward slope--need to contact owner. FIELD_STRUCT_DESC: [Mossdale Outfall] 5 of 6. 30-inch steel drainage pipe through levee at unknown depth. Structure is part of Lathrop City Stormwater Pump Station 112. Station consists 6 drainage pipes, pump station, air release valves, and concrete headwall. Air release valves located inside risers are located on landside (LS) shoulder on top of concrete pad. Concrete headwall and gates located on waterside (WS). (six 30-inch pipes authorized under Permit No. 17792, 2005 - City of Lathrop) FS Date: 2/4/2010

Surface erosion on waterward side.

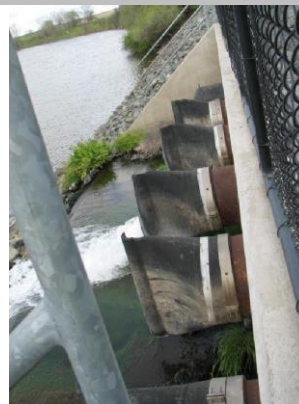
Photo 2 of 3 : UCIP_SP_2018_40701_72469.jpg

Comment Code					
Inspector Comment					
FS_ID:40701 DS_ID:477 EP_NO: 17792 Repair Type: Non-Urgent Crossing Status: Found UCIP Comments: Surface erosion on waterward slope--need to contact owner. FIELD_STRUCT_DESC: [Mossdale Outfall] 6 of 6. 30-inch steel drainage pipe through levee at unknown depth. Structure is part of Lathrop City Stormwater Pump Station 112. Station consists 6 drainage pipes, pump station, air release valves, and concrete headwall. Air release valves located inside risers are located on landside (LS) shoulder on top of concrete pad. Concrete headwall and gates located on waterside (WS). (six 30-inch pipes authorized under Permit No. 17792, 2005 - City of Lathrop) FS Date: 2/4/2010

Outlet concrete headwall and gates on waterward toe.

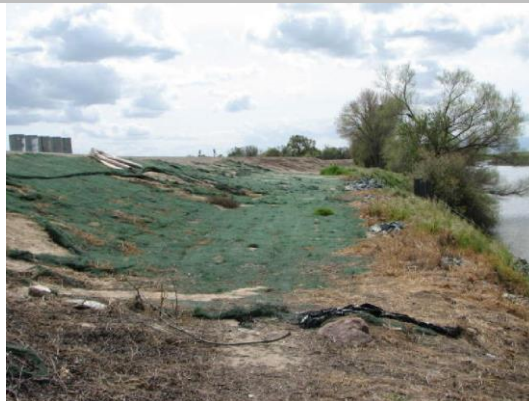
Photo 3 of 3 : UCIP_SP_2018_40701_72468.jpg

Item	DWR UCIP Field Study			37.802837 °	37.802837 °	
				-121.311949 °	-121.311949 °	
DWR ID						
Comment Code						
Inspector Comment						
FS_ID:40701 DS_ID:477 EP_NO: 17792 Repair Type: Non-Urgent Crossing Status: Found UCIP Comments: Surface erosion on waterward slope--need to contact owner. FIELD_STRUCT_DESC: [Mossdale Outfall] 6 of 6. 30-inch steel drainage pipe through levee at unknown depth. Structure is part of Lathrop City Stormwater Pump Station 112. Station consists 6 drainage pipes, pump station, air release valves, and concrete headwall. Air release valves located inside risers are located on landside (LS) shoulder on top of concrete pad. Concrete headwall and gates located on waterside (WS). (six 30-inch pipes authorized under Permit No. 17792, 2005 - City of Lathrop) FS Date: 2/4/2010

View of waterward side.

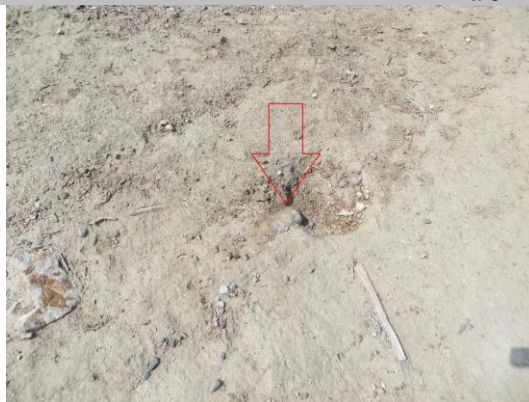
Photo 1 of 3 : UCIP_SP_2018_45463_74122.jpg

LM Start	11.43	Rating **	M	Issue No.	136
LM End	11.43	Issue Type +	En	Location *	
Category	Supplemental			GPS Latitude/Longitude	
				Start	End
Item	DWR UCIP Field Study			37.801683 °	37.801683 °
				-121.312001 °	-121.312001 °
DWR ID					
Comment Code					
Inspector Comment					
FS_ID:45463 DS_ID:53 EP_NO: 15125 Repair Type: Non-Urgent Crossing Status: Indicator Found UCIP Comments: Pipe appears abandoned as vent is partially burried and pipe not visilbe. If abandoned, it should be done so properly. FIELD_STRUCT_DESC: 7-inch steel pipe through the levee 3.59-feet below levee crown. Siphon breaker located on landside (LS) shoulder. Air vent found on waterside (WS) slope (7-inch installed under Permit No. 15125, 1989 - T. Osborn, Jr., existing 8-inch PVC pipe removed). [Additional Reference(s): DWR Levee Logs, 1981 and 2003] FS Date: 5/21/2015

Vent visible on WS slope. Found partially buried.

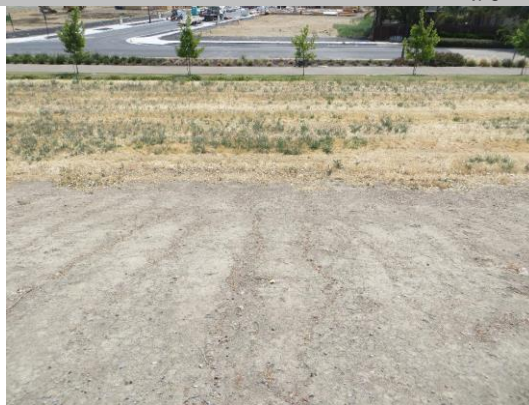
Photo 3 of 3 : UCIP_SP_2018_45463_74120.jpg

LS slope. No indication of pipe.

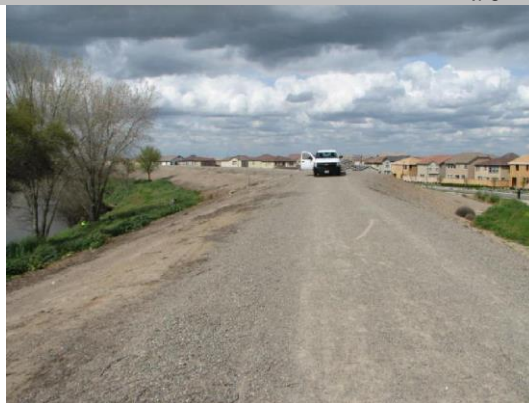
Photo 1 of 3 : UCIP_SP_2018_40702_72481.jpg

Comment Code					
Inspector Comment					
FS_ID:40702 DS_ID:806 EP_NO: N/A Repair Type: Non-Urgent Crossing Status: Found UCIP Comments: No pipe found during site visit only air valve and power meter. Dense vegetation along waterward slope recommend clearing vegetation from slope to conduct proper pipe inspection. If crossing is no longer in use owner will need to coordinate with DWR inspector and CVFPB to remove according to Title 23 requirements. FIELD_STRUCT_DESC: *REMOVED* 20-inch steel drainage pipe through the levee 5-feet below the crown. Siphon breaker in steel riser on waterside (WS) shoulder and a flap gate on the WS toe. (20-inch pipe authorized under Permit No. 3799, 1961 - Libbey-Owens-Ford Glass Company; 24-inch pipe removed under Permit No. 15318, 1989 - Libby-Owens-Ford Glass Co. & Reclamation District 17 [RD0017], 20-inch pipe installed) [Additional Reference(s): DWR Levee Logs, 1981, 2003, 20-inch. USACE San Joaquin O&M Manual Unit No. 2, May 1963, (HLM 12.16), 20-inch pipe] FS Date: 2/4/2010

Overview of levee crown at crossing.

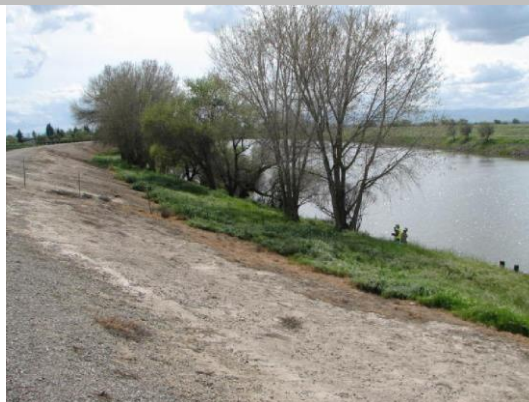
Photo 2 of 3 : UCIP_SP_2018_40702_72480.jpg

View of waterward side.

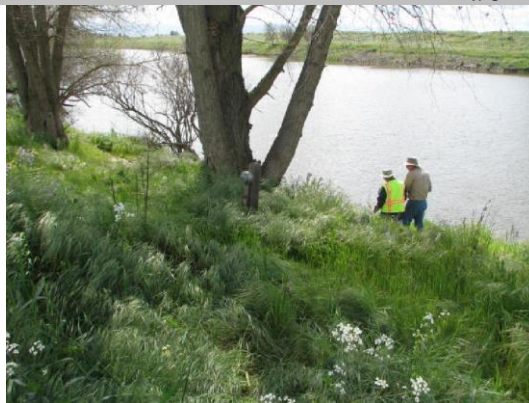
Photo 3 of 3 : UCIP_SP_2018_40702_72483.jpg

Item	DWR UCIP LMA Responsibility			37.793831 °	37.793831 °	
				-121.305989 °	-121.305989 °	
DWR ID						
Comment Code						
Inspector Comment						
FS_ID:40702 DS_ID:806 EP_NO: N/A Repair Type: Non-Urgent Crossing Status: Found UCIP Comments: No pipe found during site visit only air valve and power meter. Dense vegetation along waterward slope recommend clearing vegetation from slope to conduct proper pipe inspection. If crossing is no longer in use owner will need to coordinate with DWR inspector and CVFPB to remove according to Title 23 requirements. FIELD_STRUCT_DESC: *REMOVED* 20-inch steel drainage pipe through the levee 5-feet below the crown. Siphon breaker in steel riser on waterside (WS) shoulder and a flap gate on the WS toe. (20-inch pipe authorized under Permit No. 3799, 1961 - Libbey-Owens-Ford Glass Company; 24-inch pipe removed under Permit No. 15318, 1989 - Libby-Owens-Ford Glass Co. & Reclamation District 17 [RD0017], 20-inch pipe installed) [Additional Reference(s): DWR Levee Logs, 1981, 2003, 20-inch. USACE San Joaquin O&M Manual Unit No. 2, May 1963, (HLM 12.16), 20-inch pipe] FS Date: 2/4/2010

Dense vegetation along waterward slope--abandoned electrical box is visible through dense vegetation.

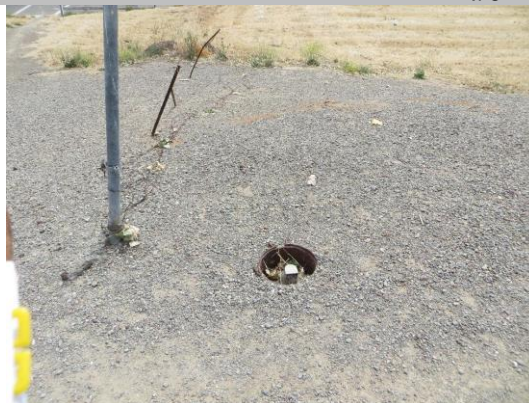
Photo 1 of 3 : UCIP_SP_2018_45464_74125.jpg

Comment Code					
Inspector Comment					
FS_ID:45464 DS_ID:56 EP_NO: 15318 Repair Type: Non-Urgent Crossing Status: Indicator Found UCIP Comments: Crossings appears to be abandoned. Need to contact owner to determine status of crossing. If abandoned, it should be done so properly. FIELD_STRUCT_DESC: 20-inch steel drainage pipe through levee, 3.4-feet below levee crown. Air vent in 12-inch steel riser found on the landside (LS) shoulder. Electric service riser on waterside (WS) berm has been removed. (20-inch pipe authorized under Permit No. 15318, 1989 - Libby-Owens-Ford Glass Co. & Reclamation District 17 [RD0017], 24-inch pipe removed) [Additional Reference(s): DWR Levee Logs, 1981 and 2003] FS Date: 5/21/2015

Vent in steel riser on LS shoulder.

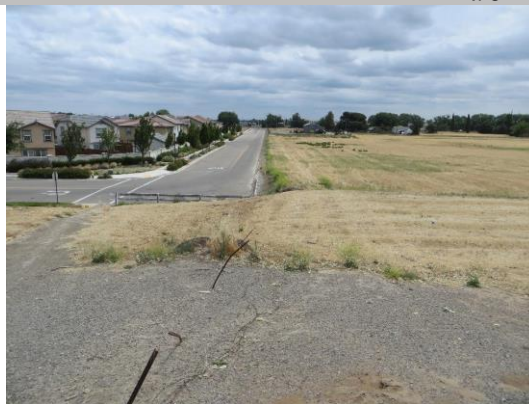
Photo 2 of 3 : UCIP_SP_2018_45464_74124.jpg

View of LS at crossing.

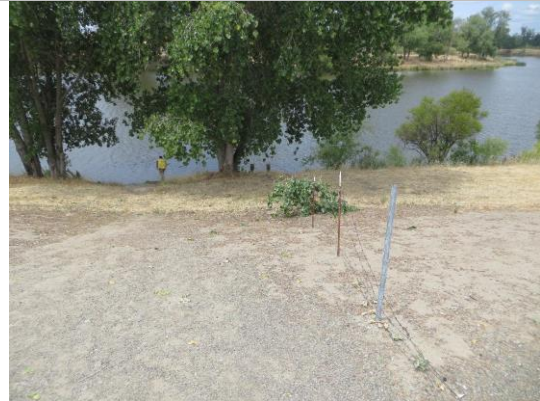
Photo 3 of 3 : UCIP_SP_2018_45464_74123.jpg

Item	DWR UCIP Field Study			37.793831 °	37.793831 °	
				-121.305989 °	-121.305989 °	
DWR ID						
Comment Code						
Inspector Comment						
FS_ID:45464 DS_ID:56 EP_NO: 15318 Repair Type: Non-Urgent Crossing Status: Indicator Found UCIP Comments: Crossings appears to be abandoned. Need to contact owner to determine status of crossing. If abandoned, it should be done so properly. FIELD_STRUCT_DESC: 20-inch steel drainage pipe through levee, 3.4-feet below levee crown. Air vent in 12-inch steel riser found on the landside (LS) shoulder. Electric service riser on waterside (WS) berm has been removed. (20-inch pipe authorized under Permit No. 15318, 1989 - Libby-Owens-Ford Glass Co. & Reclamation District 17 [RD0017], 24-inch pipe removed) [Additional Reference(s): DWR Levee Logs, 1981 and 2003] FS Date: 5/21/2015

View of WS at crossing.

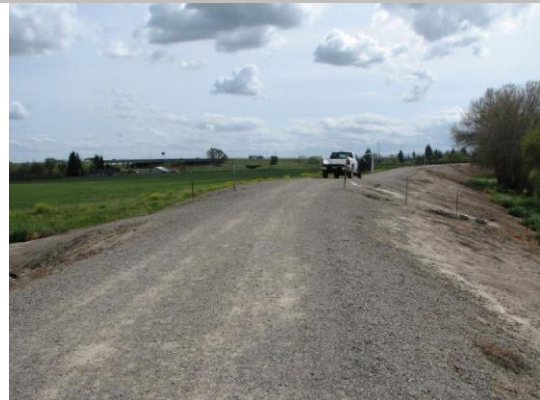
Photo 1 of 3 : UCIP_SP_2018_40703_72487.jpg

Comment Code					
Inspector Comment					
FS_ID:40703 DS_ID:799 EP_NO: N/A Repair Type: Non-Urgent Crossing Status: Found UCIP Comments: Need to contact owner to determine status of crossing and obtain additional information about crossing (permit and install date). FIELD_STRUCT_DESC: 48-inch steel drainage pipe through the levee, 2.5-feet below the crown. Siphon breaker on landside (LS) shoulder. Concrete "U" shaped headwall on waterside (WS) toe with flap gate. 8-4 inch steel coated scheduled 40 pipes located on WS shoulder about 6 inch cover. (48-inch pipe and 12-inch pipe authorized under Permit No. 15845, 1993 - City of Lathrop and Kearny Ventures) FS Date: 2/4/2010

Overview of levee crown at crossings.

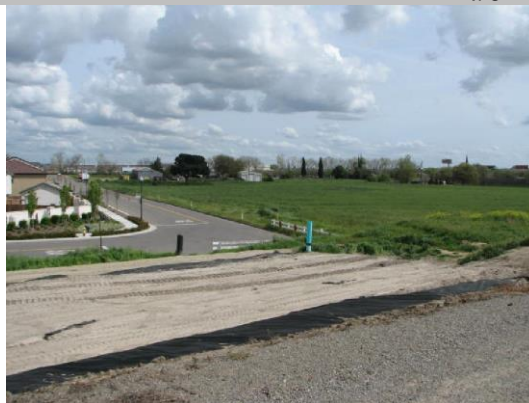
Photo 2 of 3 : UCIP_SP_2018_40703_72485.jpg

View of landward side, photo 1 of 2.

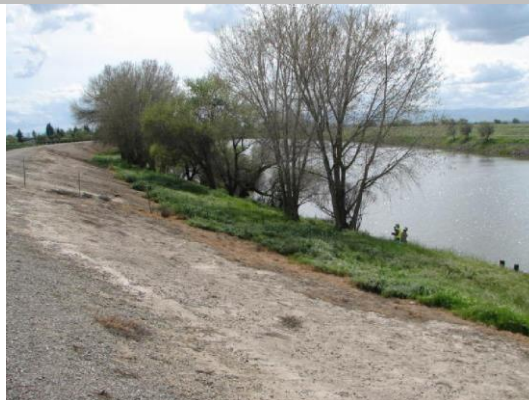
Photo 2 of 3 : UCIP_SP_2018_45993_72495.jpg

View of waterward side.

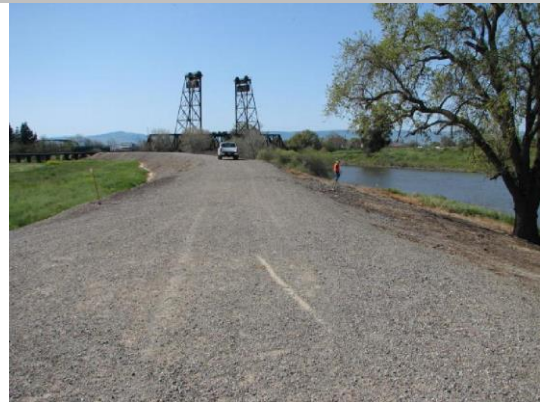
Photo 1 of 3 : UCIP_SP_2018_40706_72509.jpg

Comment Code						
Inspector Comment						
FS_ID:40706 DS_ID:807 EP_NO: N/A Repair Type: Non-Urgent Crossing Status: Found UCIP Comments: Pipe disconnected on waterward side. Need to contact owner to determine status of crossing. If crossing is no longer in use owner will need to coordinate with DWR inspector and CVFPB to remove according to Title 23 requirements. FIELD_STRUCT_DESC: 8-inch irrigation pipe of unknown material through levee, 3.2-feet below the crown. Pump on waterside (WS) toe and a siphon breaker on the landside (LS) shoulder. (6-inch pipe authorized under Permit No. 15049, 1989 - T. and I. Queirolo, existing 6-inch pipe removed) [Additional Reference(s): DWR Levee Logs, 1981 and 2003] FS Date: 2/4/2010

Overview of levee crown at crossing.

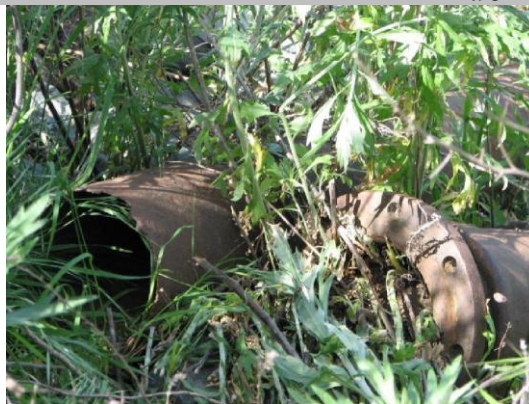
Photo 3 of 3 : UCIP_SP_2018_40706_72512.jpg

Non-functional crossing pipe disconnected.

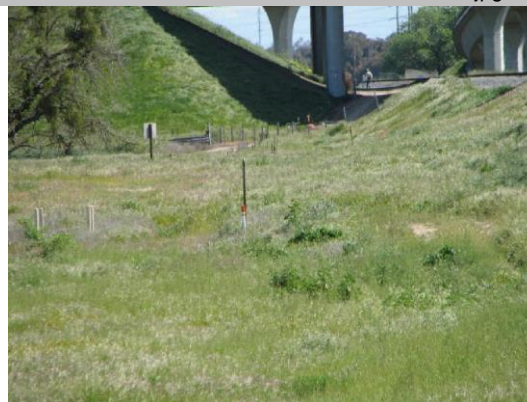
Photo 2 of 3 : UCIP_SP_2018_40707_72514.jpg

Crossing alignment along landward side.

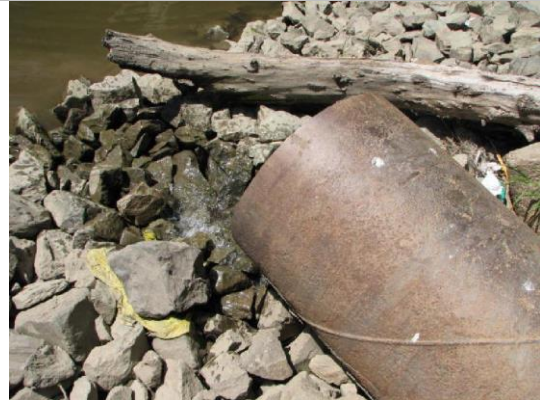
Photo 1 of 3 : UCIP_SP_2018_45466_72523.jpg

Comment Code					
Inspector Comment					
FS_ID:45466 DS_ID:808 EP_NO: 2366 Repair Type: Non-Urgent Crossing Status: Found UCIP Comments: Pipe exposed on WS slope where soil has been removed from around pipe. There does not appear to be any damage or repair at excavation. Pipe should be buried. FIELD_STRUCT_DESC: 22-inch steel drainage pipe through the levee, 10-feet below levee crown. 54-inch square, concrete manhole at the centerline of the levee between Manthey Road and the HWY 120 on ramp to I-5. (22-inch pipe authorized under Permit No. 2366, 1956 - State of California Department of Public Works Division of Highways District X) [Additional Reference(s): DWR Levee Logs, 1981, 2003, 22-inch listed. USACE San Joaquin O&M Manual Unit No. 2, May 1963, (HLM 12.74), 22-inch pipe] FS Date: 5/21/2015

Pipe was running during field inspection.

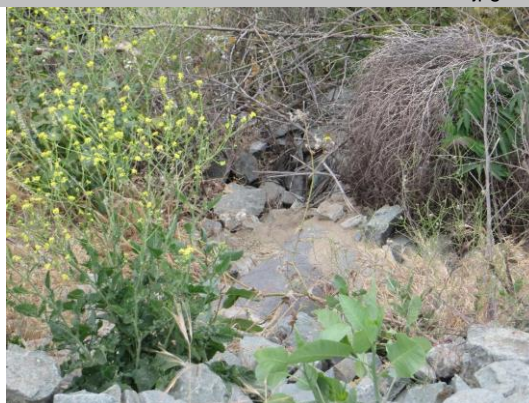
Photo 3 of 3 : UCIP_SP_2018_45466_74130.jpg

Pipe exposed in excavated area on WS slope.

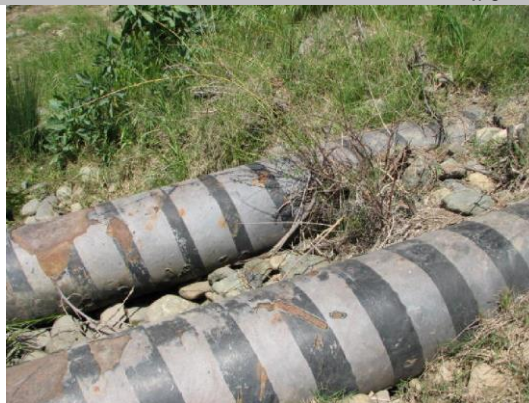
Photo 2 of 3 : UCIP_SP_2018_40713_72533.jpg

LM Start	13.26	Rating **	M	Issue No.	146 (cont)	
LM End	13.26	Issue Type +	En	Location *		
Category	Supplemental			GPS Latitude/Longitude		
				Start	End	
Item	DWR UCIP Field Study			37.779643 °	37.779643 °	
				-121.300057 °	-121.300057 °	
DWR ID						
Comment Code						
Inspector Comment						
FS_ID:40713 DS_ID:287 EP_NO: 14450 Repair Type: Non-Urgent Crossing Status: Found UCIP Comments: Need to contact owner to determine status of crossing. FIELD_STRUCT_DESC: [Oakwood Lake Discharge Lines] 2 of 2. 18-inch steel drainage discharge pipe through levee at unknown depth below the levee crown. (two 18-inch pipes authorized under Permit No. 14450-1985 - R. H. Brown, remove existing 18-inch pipe) [Additional Reference(s): DWR Levee Logs, 1981 and 2003] FS Date: 2/4/2010

Pipes visible on waterward side.

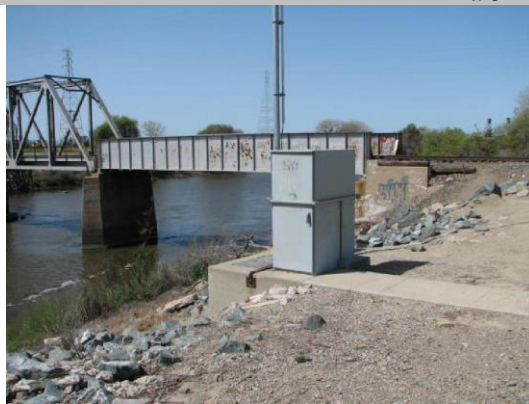
Photo 2 of 3 : UCIP_SP_2018_40714_72539.jpg

Control box and distribution box located on waterward shoulder.

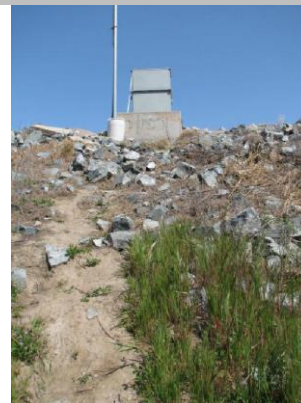
Photo 3 of 3 : UCIP_SP_2018_40714_72542.jpg

View of waterward side.

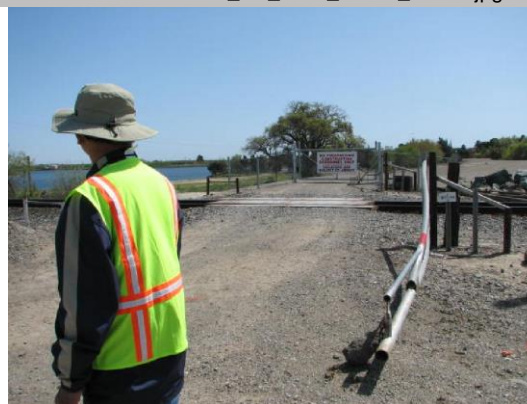
Photo 1 of 2 : UCIP_SP_2018_45995_72526.jpg

LM Start	13.28	Rating **	M	Issue No.	148							
LM End	13.28	Issue Type +	En	Location *								
Category	Supplemental		GPS Latitude/Longitude									
			Start	End								
Item	DWR UCIP Field Study		37.779470 °	37.779470 °								
			-121.299954 °	-121.299954 °								
DWR ID												
Comment Code												
Inspector Comment												
FS_ID:45995 DS_ID:67 EP_NO: N/A Repair Type: Non-Urgent Crossing Status: Indicator Found UCIP Comments: Markers visible on landward side only. Recommend contacting owner to confirm alignment and crossing. FIELD_STRUCT_DESC: Submarine power cable through the levee and across the channel. [Additional Reference(s): DWR Levee Logs, 1981 and 2003] FS Date: 2/4/2010

View of levee crown at crossing.

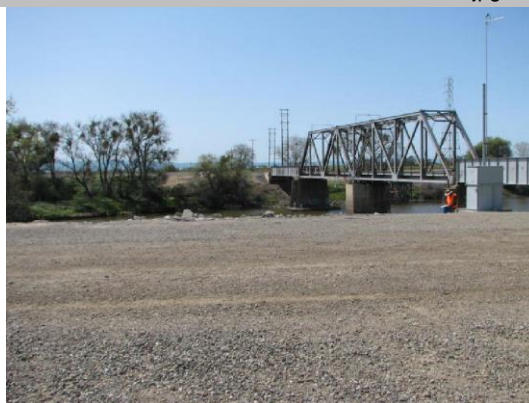
Photo 1 of 3 : UCIP_SP_2018_40715_72548.jpg

Comment Code						
Inspector Comment						
FS_ID:40715 DS_ID:809 EP_NO: N/A Repair Type: Non-Urgent Crossing Status: Found UCIP Comments: No information was obtained from desk study. This crossing was found during field visit. Need to contact owner to obtain additional details about crossing (installation date and permit) and status. FIELD_STRUCT_DESC: *ABANDONED* [Reclamation District No. 17 Drainage Plant] 18-inch drainage pipe of unknown material through the levee, 5.8 feet below the crown. Gate valve and siphon breaker on the waterside (WS) slope. Flap gate on the WS end. One CM cutoff wall. Pump on the landside (LS). (18-inch pipe Installed by USACE in 1961 -- no permit found; existing 18-inch pipe removed under Permit No. 14450, 1988 - R. H. Brown, two 18-inch pipes installed) [Additional Reference(s): DWR Levee Logs, 1981, 2003. USACE San Joaquin O&M Manual Unit No. 2, May 1963, (HLM 13.36)] FS Date: 2/4/2010

View of levee crown at crossing.

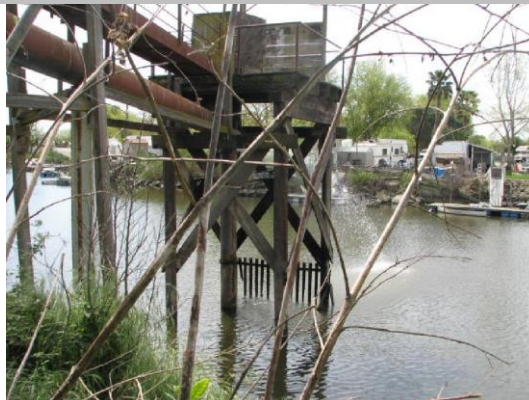
Photo 2 of 3 : UCIP_SP_2018_40716_72556.jpg

Comment Code					
Inspector Comment					
FS_ID:40716 DS_ID:69 EP_NO: 15165 Repair Type: Non-Urgent Crossing Status: Found UCIP Comments: Pump was working during the survey. Levee toe erosion at waterward side. Recommend contacting owner to determine status and to evaluate erosion at waterward toe. FIELD_STRUCT_DESC: 20-inch steel irrigation pipe through the levee, 1.7-feet below the crown. Pump on pile structure in the stream. Wooden walkway to the pump. concrete distribution box at the toe of the landside (LS) slope. (20-inch pipe authorized under Permit No. 15165, 1989 - Baird Lands, Inc., existing 18-inch pipe removed) [Additional Reference(s): DWR Levee Logs, 1981 and 2003] FS Date: 2/4/2010

Pipe operable during survey.
